The Life Cycle of Your Roof

Homeowner's Guide: What to Expect From Your CertainTeed Roof

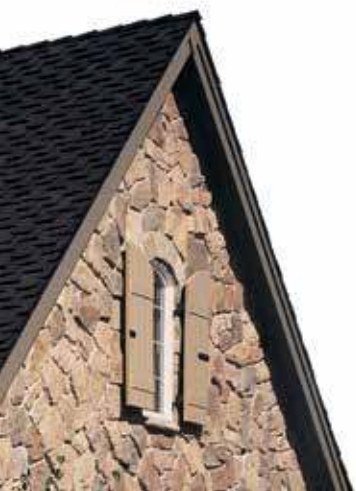
Curling

Applique Surface Cracking

Bli

CURLING: As the asphalt hardens over time, the granules which were once securely embedded begin to break away. Occasionally you may have seen the colored granules in your gutters. Also, as this hardening advances, the asphalt layers begin to shrink. Of course, all of this is occurring at a microscopic level and is not something which will be noticeable on a daily basis. As the asphalt layer shrinks, it is being countered by the shingle reinforcement, which resists shrinking. We now have a situation in which the top and bottom coatings are shrinking and the

reinforcement is remaining stable. As a result, the edges of the shingle may begin to curl over time. In addition, organic shingles may exhibit signs of curling which might be considered excessive, however, this is not a manufacturing defect and would be considered part of the normal weathering process of organic shingles.

SURFACE CRACKING: Another manifestation of the normal aging process may be the development of surface cracks. For example, as the flexibilizing oils of the asphalt are depleted due to heat, the shingle becomes more brittle, to the point where surface cracking may appear. The stresses created by thermal shock and the movement of the roof deck also increase the likelihood of surface cracking.

BLISTERS: During the course of natural weathering, small bubble-like raised areas known as blisters may appear on the surface of the shingles. The blisters may be small and pea-sized or as large as a quarter. The blisters may be open, exposing the asphalt, or closed. Blisters frequently result when minimum ventilation requirements are not met.

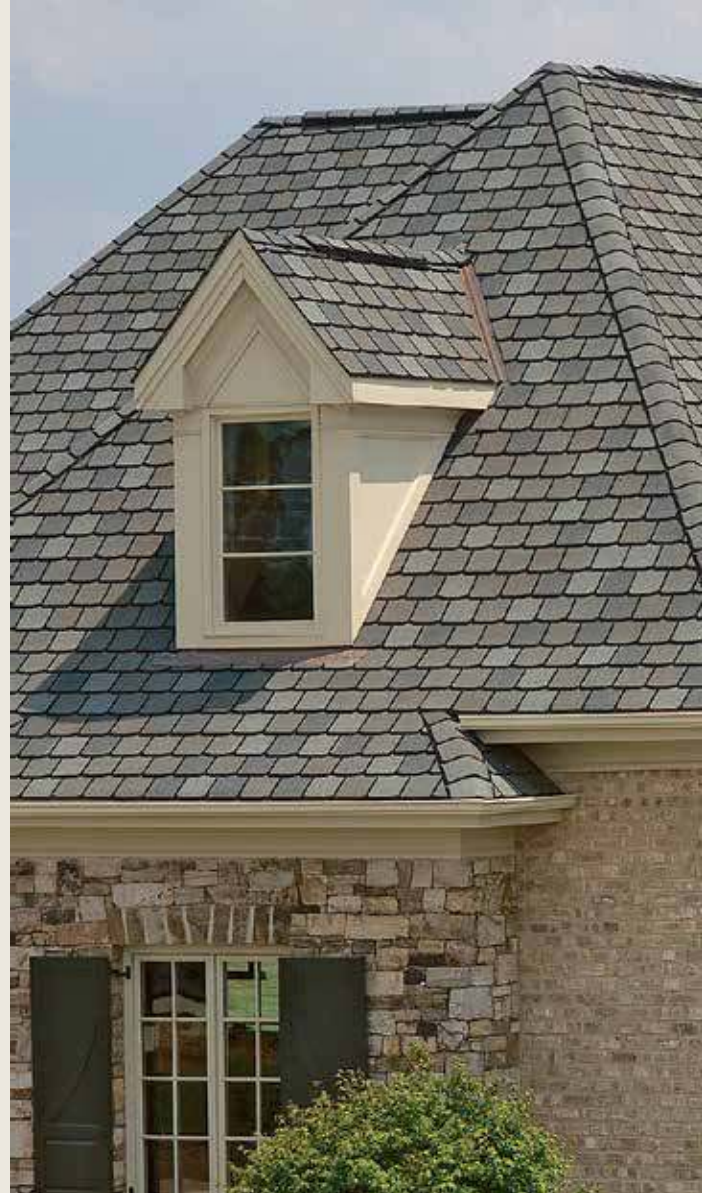
CURLING

Initial Curling

Mid-Life

Declining Years

Blisters

Algae Stains

STAINING: Finally, over a period of time, shingles may develop dark brown or black streaks that are sometimes mistaken for soot, dirt, moss or tree droppings. In actuality, this discoloration may be caused by algae growth. Although most roofing systems are susceptible to algae discoloration, it is most readily visible on white or light-colored shingles.
